Technical Report HL-96-22
December 1996

Demonstration Erosion Control Project Monitoring Program

Fiscal Year 1994 Report

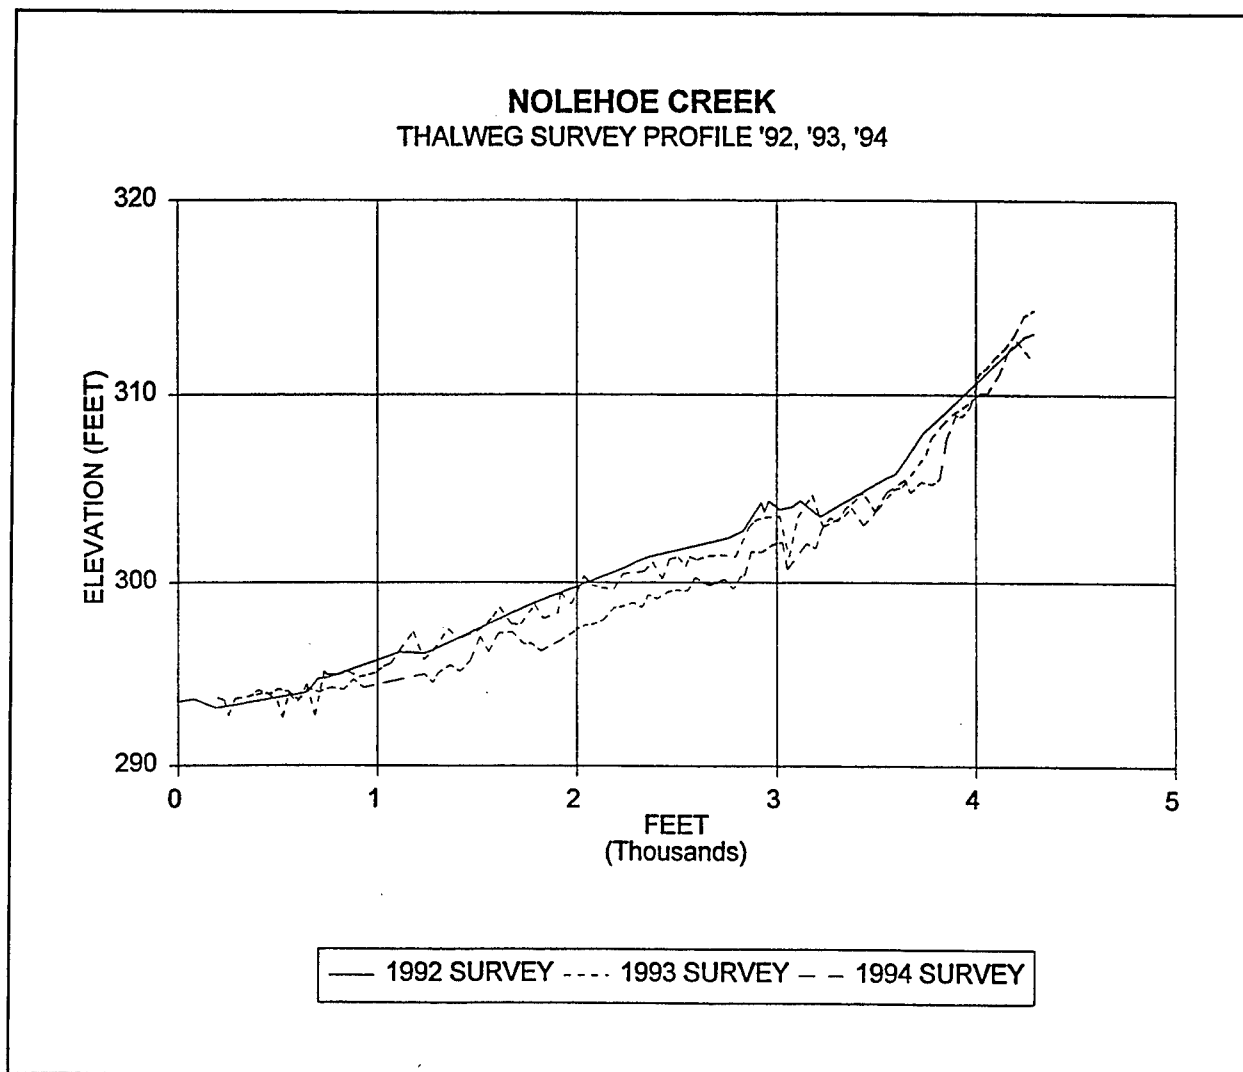
Figure 35. Nolehoe Creek, Site 7, thalweg profile

As shown in the accompanying thalweg profile (Figure 35), Nolehoe Creek has continued to degrade by approximately 4 ft between 1992 and 1994. During the November 1994 site visit, construction personnel were replacing the upstream box culvert apron and wing walls. Apparently the recent degradation has caused the need to reinforce the apron, and erosion at and around the road side of each wing wall was severe. In addition to the construction at the site, the highway that follows an east-west route approximately parallel to Nolehoe
